## THE FORGOTTEN EARTHQUAKE OF 1440 AD IN ISTRIA - ARCHAEOSEISMOLOGICAL EVIDENCE FROM THE EUPHRASIUS CATHEDRAL, POREČ, CROATIA

Miklós Kázmér<sup>1</sup>, Krzysztof Gaidzik<sup>2</sup>

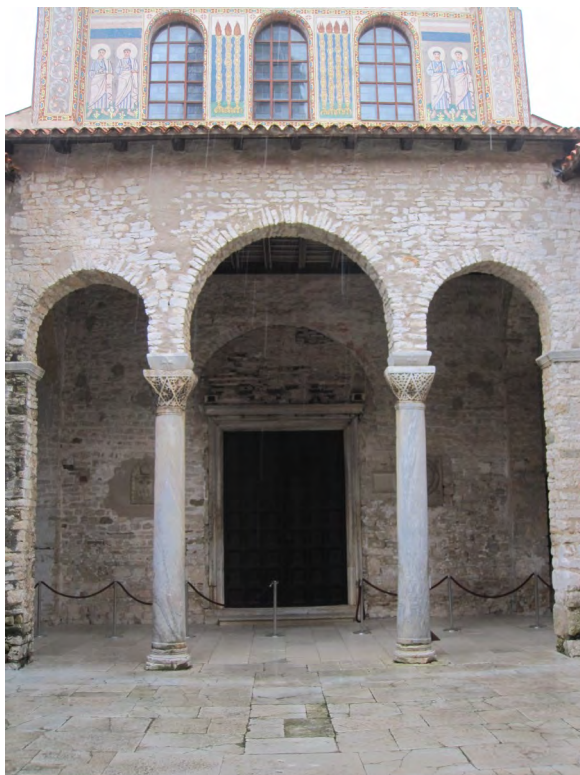
Fig. 2 - View of Euphrasius Cathedral from the western forecourt, the narthex. Archaeoseismological Database (ADB) photo #2097 (Kázmér & Gaidzik, 2023).

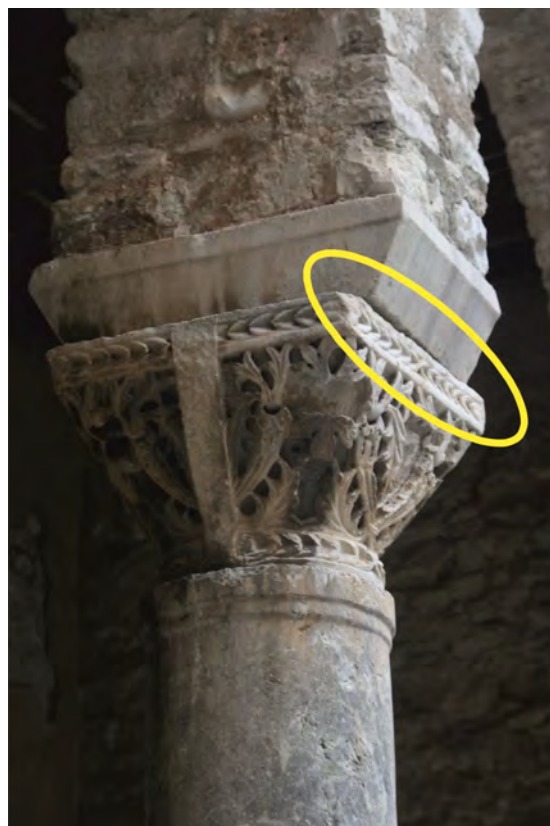
Fig. 4 - Capital of a column in the narthex (forecourt), slightly rotated counterclockwise. The misfit caused by rotation between capital and plinth is encircled. Courtesy of A. Grynaeus.

A column capital in the narthex (the western forecourt) of the church displays minor but significant counterclockwise rotation (Fig. 4). This kind of misalignment of construction elements, whose edges are supposed to be parallel, is clear evidence of lateral loading, caused by earthquakes (Hinzen et al., 2013; Cucci & Tertulliani, 2013; Hinzen, 2019).

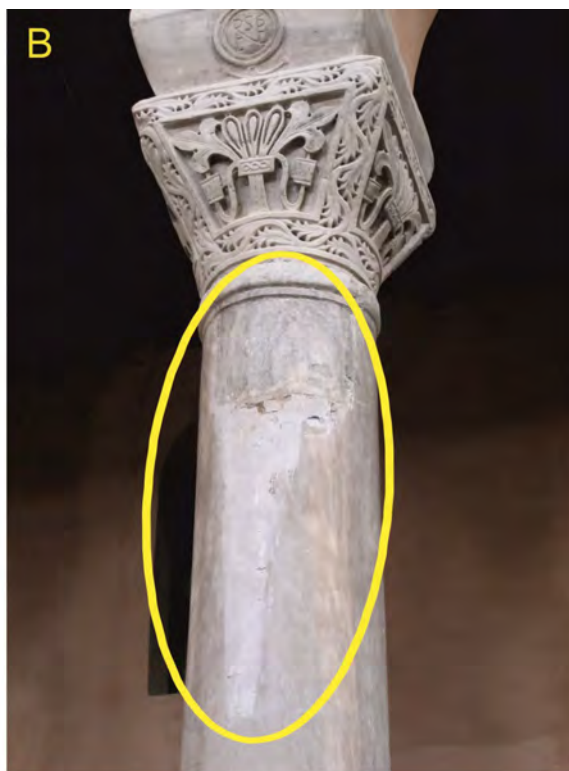
Fig. 5 - Axis-parallel fractures in a marble column. **A.** Fractures follow schistosity, a zone of weakness. Measure tape extended to 20 cm. ADB photo #2221. **B.** Fracture not following schistosity. Vertical extent of damage is ca. 1.2 m long. The separated portion of the top 30 cm was reattached during the Medieval restoration, while the remaining portion was replaced with cement. ADB photo #0085.

Columns supporting the nave of the Euphrasius Cathedral were made of Proconnesian marble, sourced from the island of Proconnesos (today Marmara) in the Marmara Sea (Terry, 1988, p. 27). The texture of this stone displays alternating dark and light parallel streaks, which are parts of large, tight folds. This inhomogeneity makes the stone prone to jointing along these planes of schistosity (Fig. 5) (Attanasio et al., 2008). Therefore, fractures parallel to schistosity were omitted from the analysis of fracturing below.

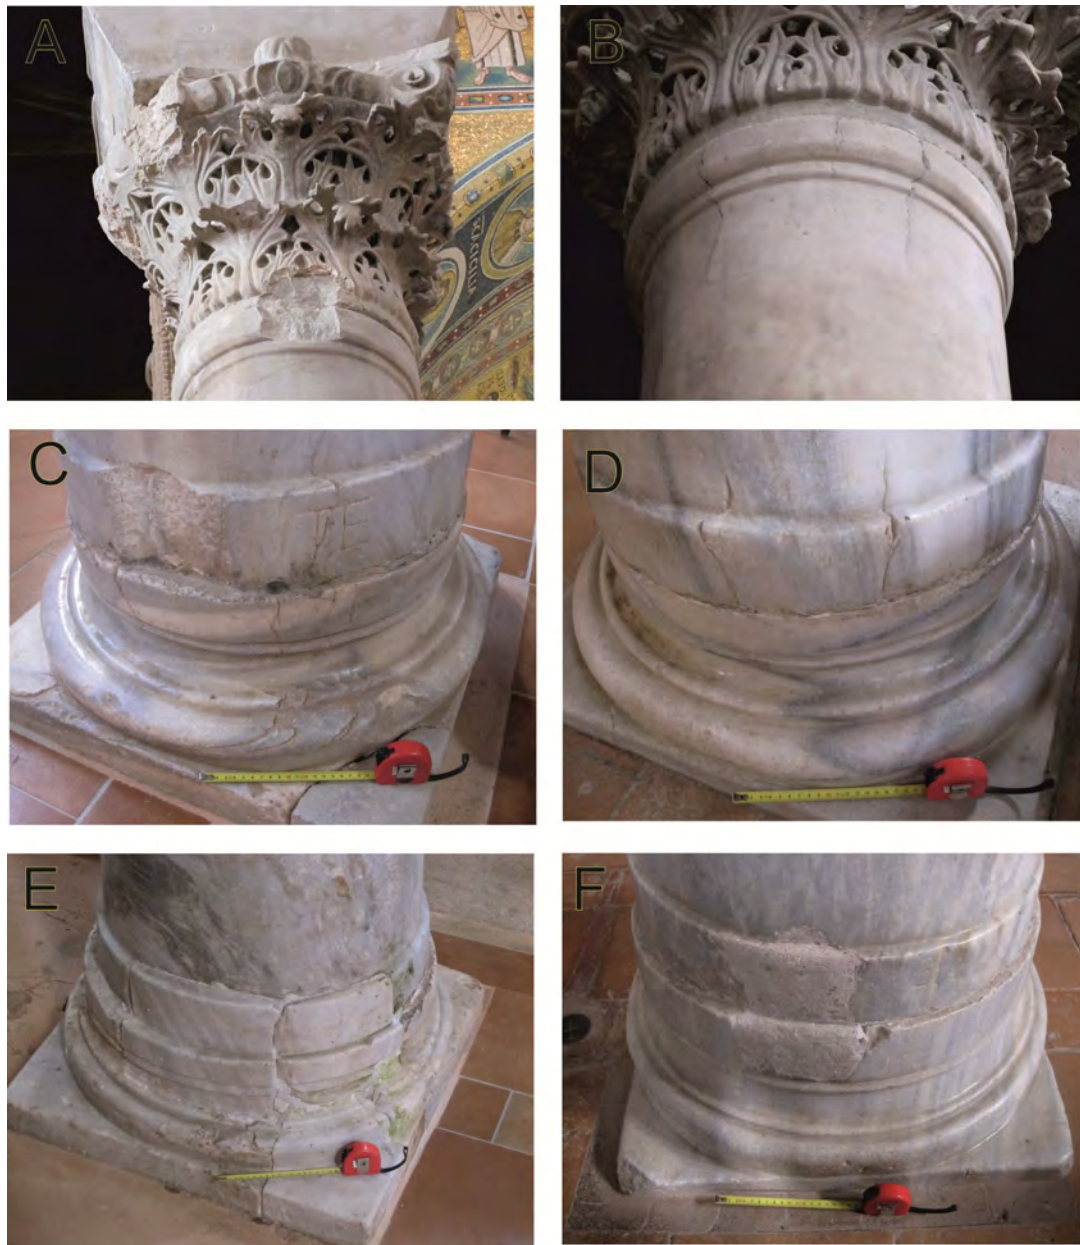
Fig. 6 - Fractured capitals, pillars, and plinths. Fracture planes are vertical, parallel with the axis of the columns, indicating the dominance of vertical shaking. A. Fully developed adjacent fracture both in the pillar and the capital. Pillar F, capital. ADB photo #0080. B. Two, conjugate joints enclose a slice of marble. If this fracture had developed further, a thin flake of stone would have been removed from the capital (see the similar feature demonstrated by Ambraseys & Psycharis, 2012, their fig. 8(b)). Pillar N, capital. ADB photo #0082. C. Broken-off corner of a pillar. An adjacent fracture marks the place where a second break-off might initiate. Pillar A, plinth. ADB photo #0076. D. Initial fracture, bordered by conjugate joints. Pillar O, plinth. ADB photo #0087. E. Broken-off splinter replaced by marble. Note the misfit of the column and the plinth: the column is narrower. Pillar I, plinth. ADB photo #0081. F. Missing splinter, repaired by concrete. Note the misfit of the column and the plinth: the column is wider. Pillar N, plinth. ADB photo #0086.

A number of columns are damaged (Fig. 6A-D).

Two types of fractures are distinguished: (1) oblique fractures, where the fracture plane is  $30\text{--}45^\circ$  to the surface. These are essentially equivalent to Marco's (2008) chipped corners and Rodriguez-Pascua's (2011, 2022) dipping broken corners. Here, fracturing can be caused by both seismic shaking and uneven loading, as well as inadvertent hits during construction and the movement of furniture. (2) Axial fractures are most certainly caused by vertical hammering by the superstructure (Kázmér, 2021) (Fig. 6).
