INTEGRATED USE OF ORTHOPHOTOS AND GEO-THEMATIC KNOWLEDGE FOR SINKHOLE RISK MITIGATION IN QUATERNARY ALLUVIAL PLAINS

Keywords: Sinkholes, alluvial plains, geophysics, orthophotos, photogrammetry.

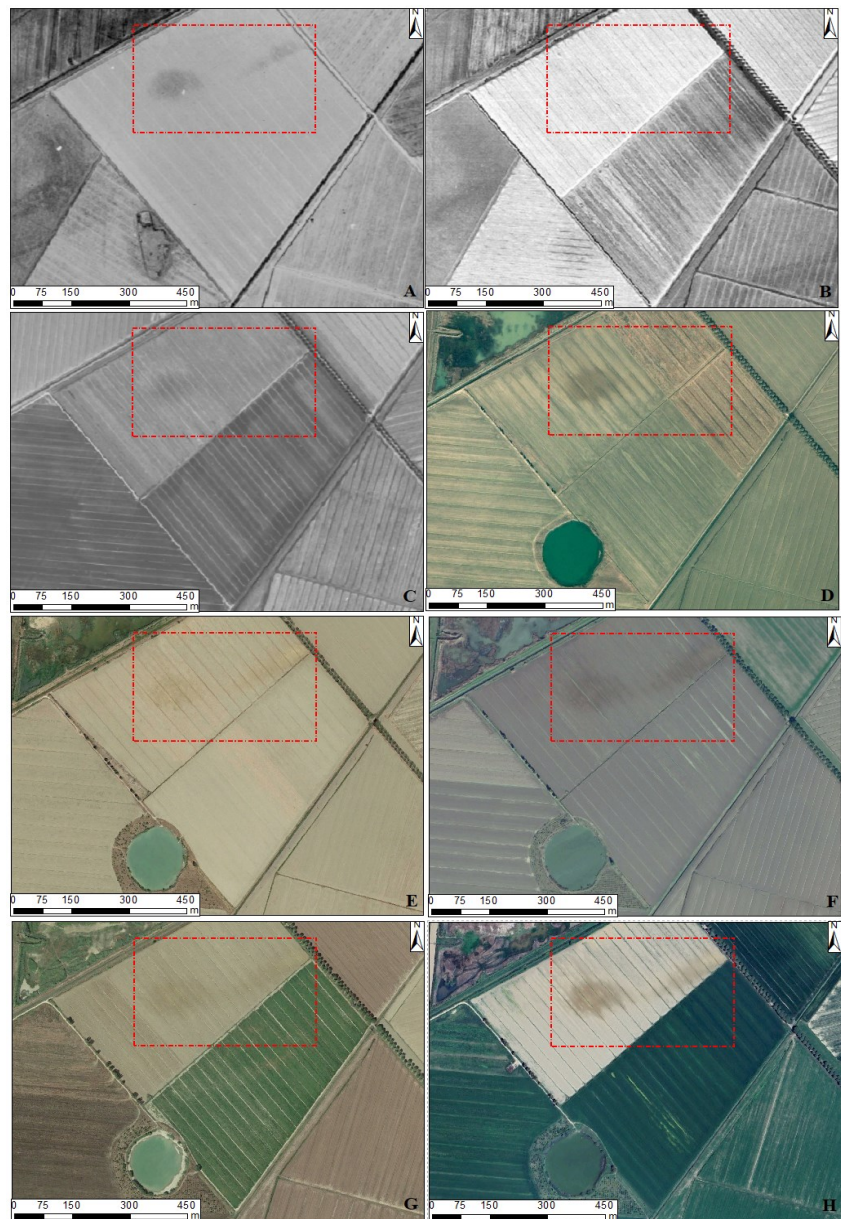
Fig. 7 - Orthophotos of the study site (in the red rectangle): 1954 (A), 1988 (B), March 2003 (C), August 2013 (D), February 2015 (E), August 2019 (F), September 2019 (G) and March 2023 (H). To the south is located the Bottegone sinkhole.

A photographic collage was also created for this site, displaying available orthophotos from 1954 to 2023 (figure 7). These images reveal dark patches consistently appearing in the same locations across various times of the year and different years.

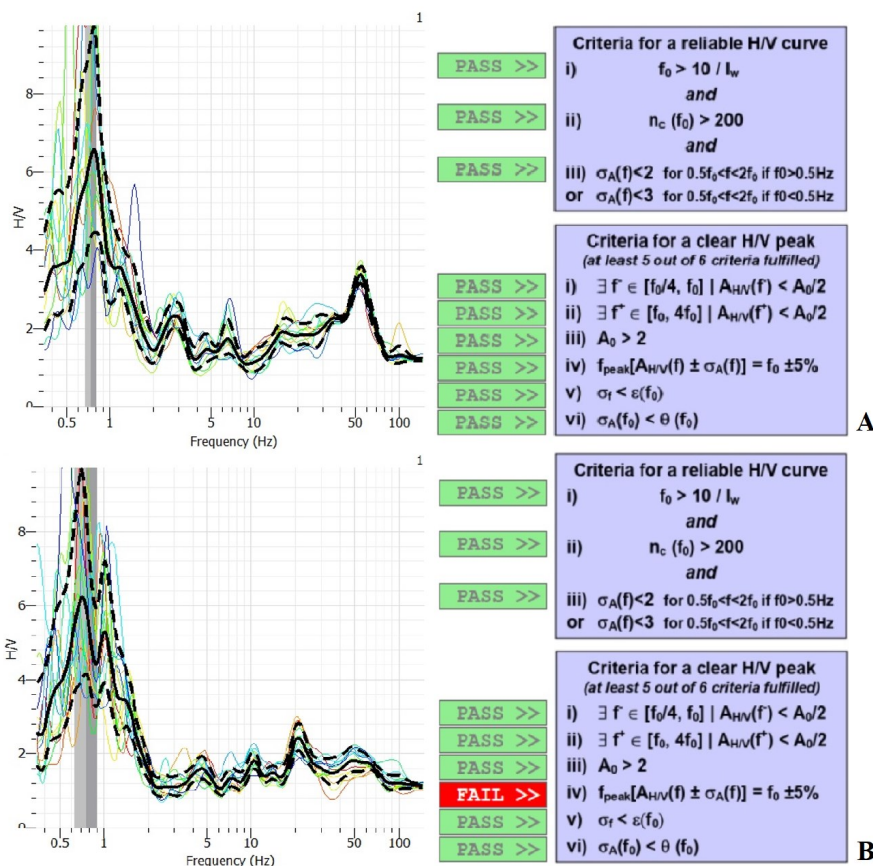
Fig. 9 - A) HVSR test in Bottegone site. B) HVSR test in the study site.

HVSR. The microtremor acquisitions lasted 25 minutes each. Processing was carried out using Goepsy software, while the SESAME criteria were checked using the HV_Test tool. Figure 9 shows the results at Bottegone sinkhole site (Fig. 9A) and at the study area site (Fig. 9B).

A frequency of 0.75 Hz was measured at the study site, while a frequency of 0.74 Hz was measured at the Bottegone sinkhole.

The HVSR tests indicate very similar frequencies to each other, and the low values suggest deep impedances of more than 100 m (Albarello et al., 2009), in agreement with the seismic tests conducted by Del Greco et al. (2004).
